UNITED STATES ENVIRONMENTAL PROTECTION AGENCY

SUBJECT: Former CertainTeed Transite Plant, St. Louis, Missouri,
Site Asbestos Evaluation, 7/19/93 (SBR23)

CERTAINTEED
ST. LOUIS, MO
NORTHEAST BUILDING
7/19/93
SBR23

CERTAINTEED, ST. LOUIS, MO
 SOUTHWEST BUILDING
 7/19/93
 SBR23

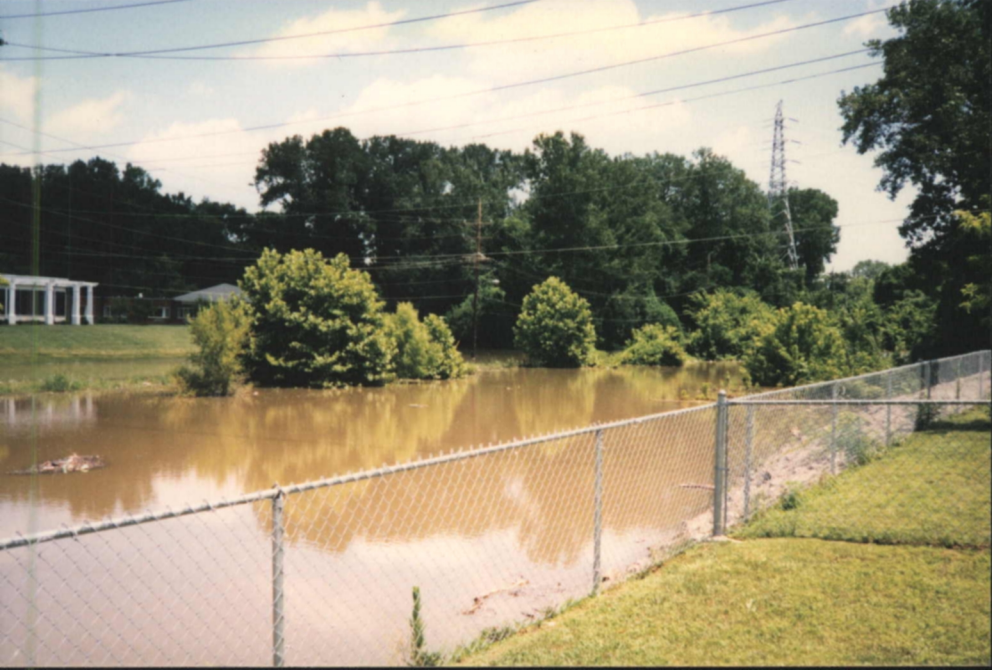
1
Photo #1

As seen in Photos #1, #2, #3, #26 and #27, Maline creek has left its banks, and has flooded some yards and part of the CertainTeed site. The creek bank containing the transite waste layer was covered with water and not visible.

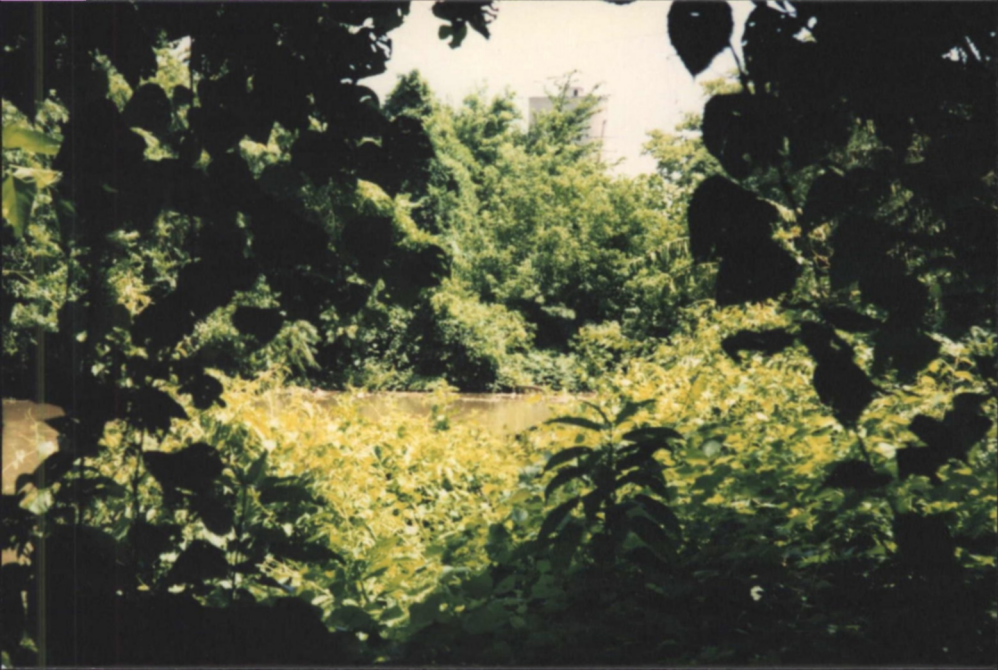
2
Photo #2

Photo taken from south side of creek towards
CertainTeed site.

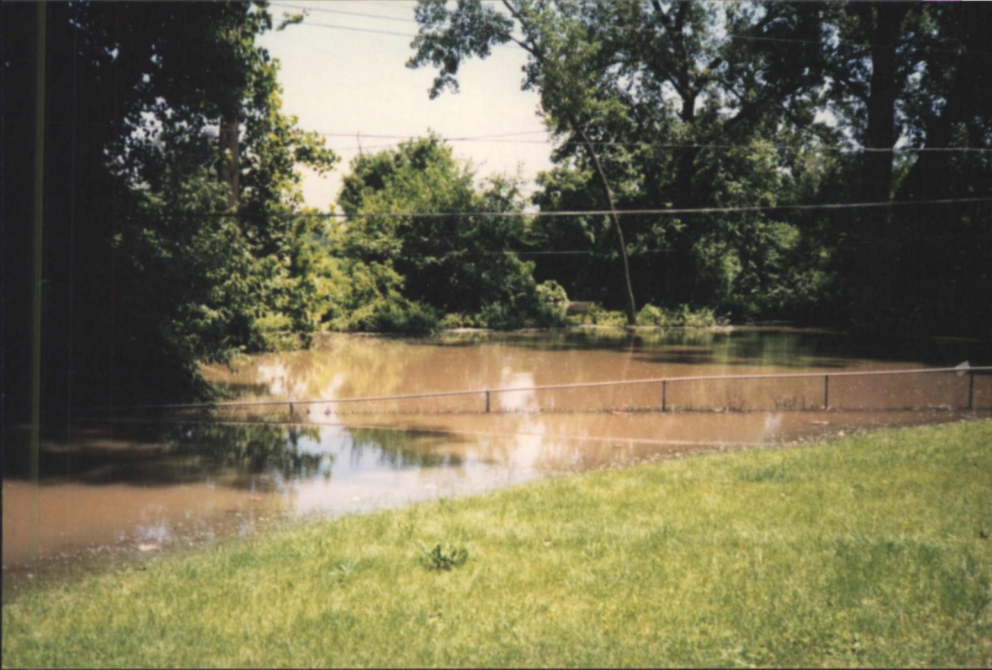
Photo #3

CAPTION: Maline Creek.

Photo taken from south side of creek towards
CertainTeed site.

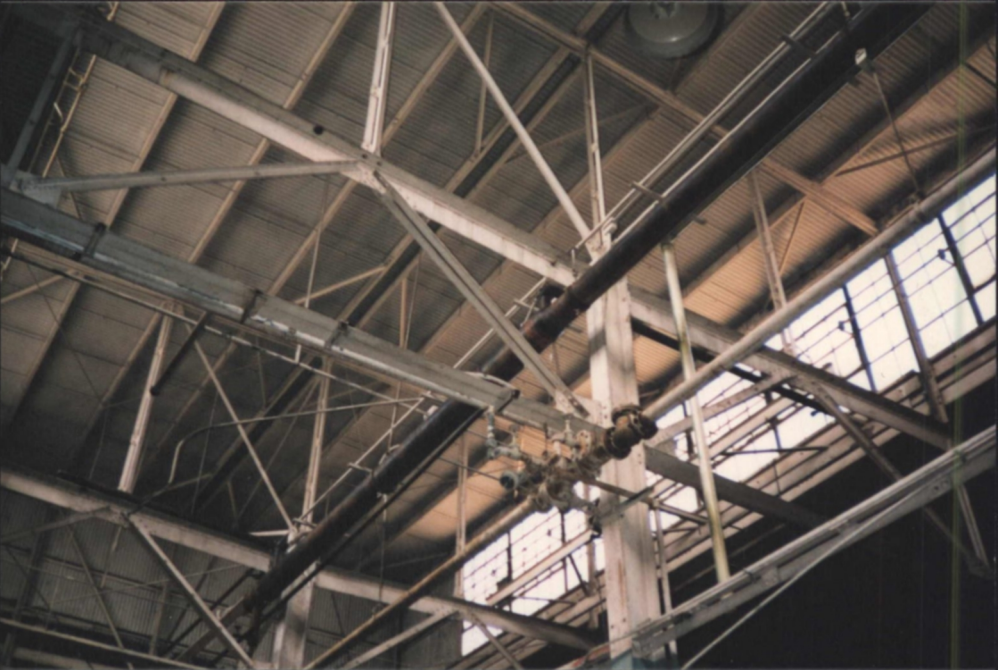
Photo #4

All of the pipe insulation in the southwest building was supposedly removed during the recent abatement project (Photo #4 and #5). All of the previously insulated pipes appeared to be adequately cleaned. Insulation debris on the ground, identified during previous inspections, had also been cleaned up. Mr. Kootman said that the abatement workers put up plastic containment walls and wet the insulation during the removal.

CAPTION: Southwest building.
Insulation removed from pipe.

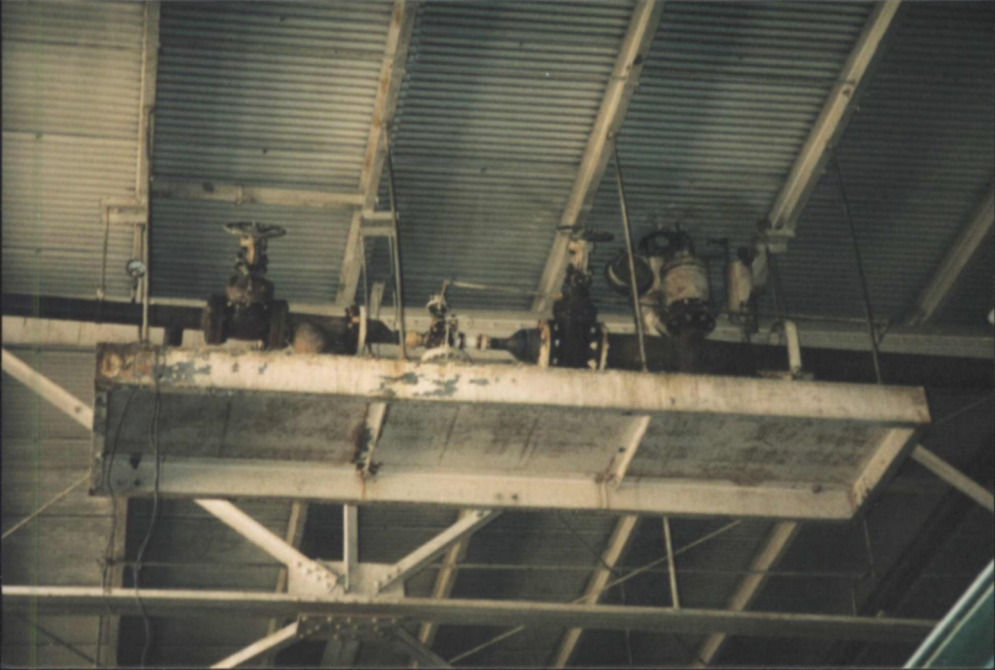
5
Photo #5

CAPTION: Southwest building.
Insulation removed from pipe.

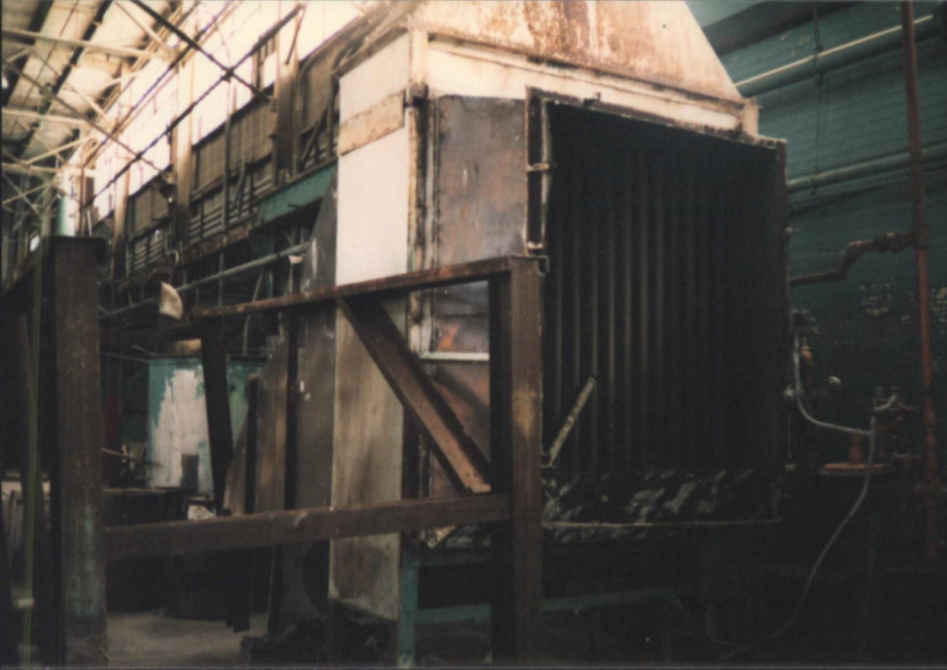
Photo #6

The insulation on the process heater had also been removed (Photo #6). There was some insulation residue left on the equipment, and some insulation residue on a pipe next to the equipment (Photo #7).

CAPTION: Southwest building. Heater.

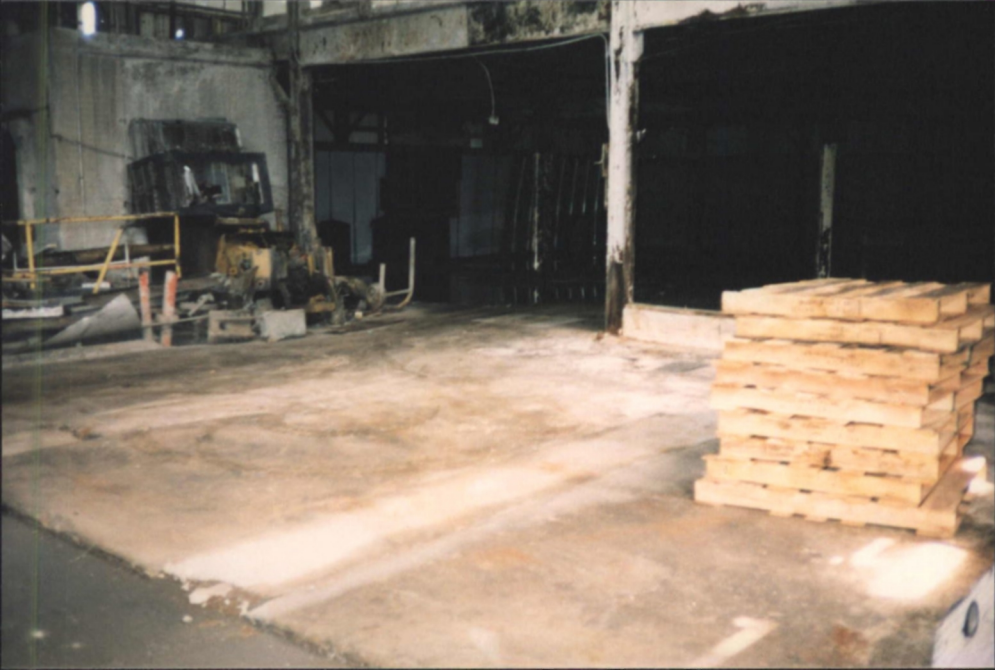
6
Photo #9

CAPTION: Northeast building, 1st floor.

Asbestos contaminated area after abatement.

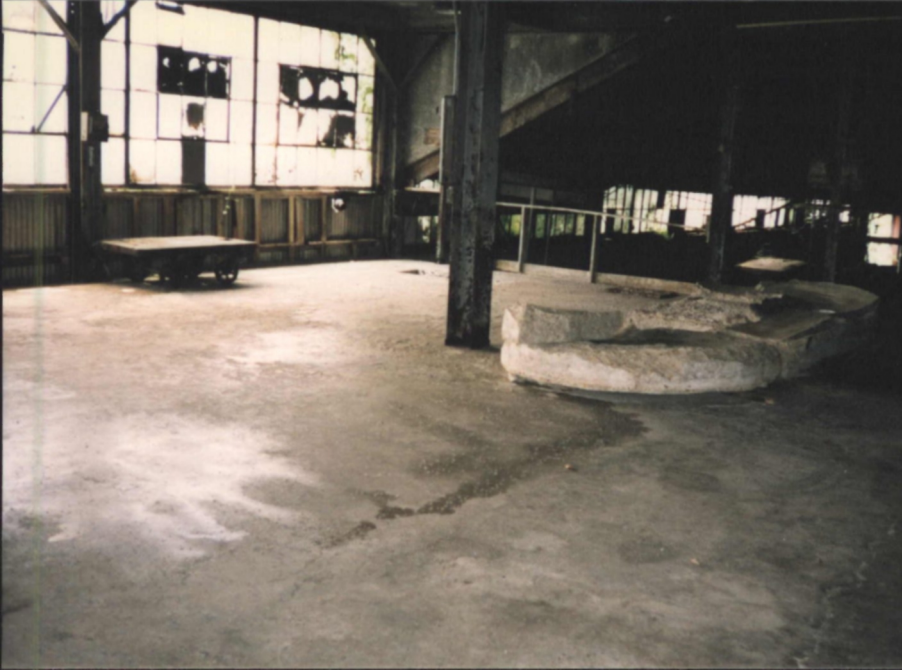
Photo #10

The floors on the 2nd and 3rd levels have been cleaned but some dust and debris remains (Photos #10, #11 and #12).

CAPTION: Northeast building, 2nd floor.

Asbestos contaminated area after abatement.

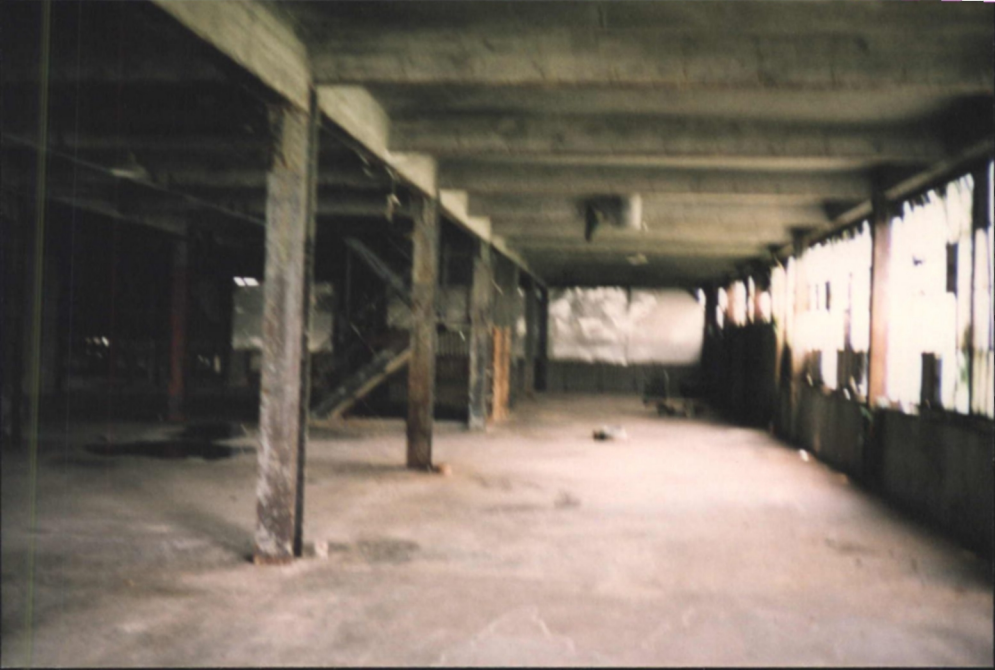
71
Photo #11

CAPTION: Northeast building, 2nd floor.

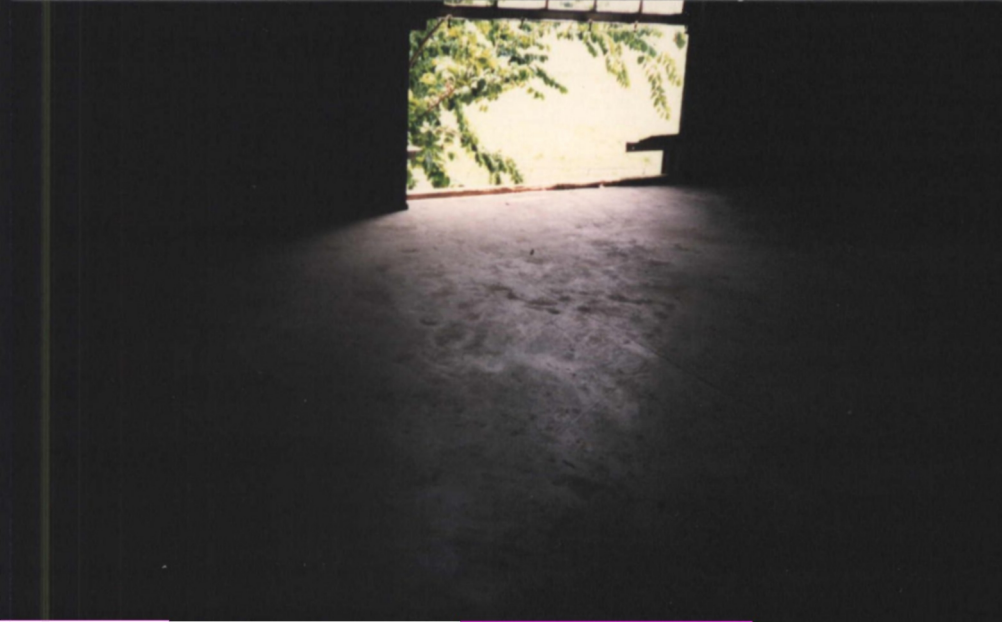
21
Photo #12

CAPTION: Northeast building, 3rd floor, southeast wall.

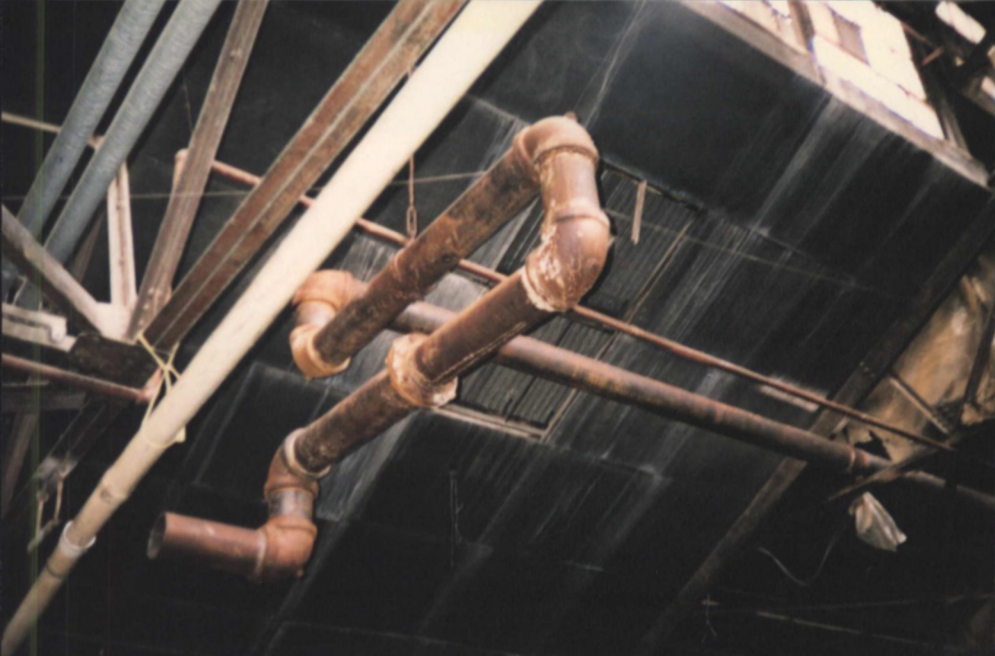
Photo #13

It appeared that the majority of the bulk ACM located in the southwest building has been cleaned-up. There is still general dust and some debris that could contain asbestos, but the areas of gross contamination appear to have been cleaned adequately (Photos #8 and #9). The insulated pipes in the northeast building, area C have been abated (Photo #13).

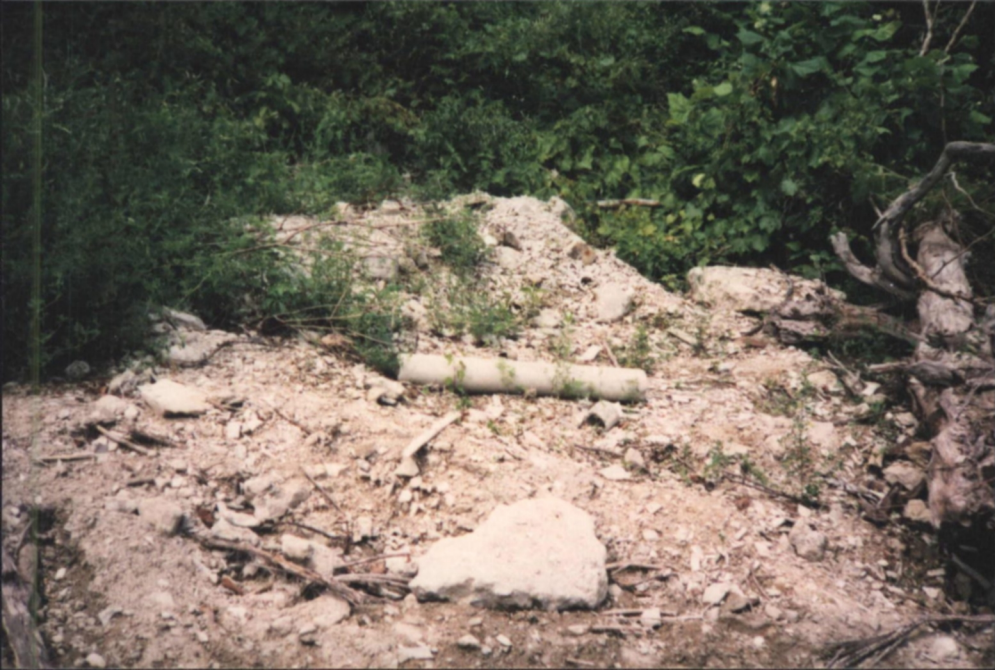
61
Photo #14

The outside area on the southeast end of the building has more transite debris visible on the surface than observed during the last inspection of 1/28/93 (Photos #14-#21). The contaminated area covers at least 5,000 square feet. Sample site SBR23-001 was obtained from a large area of transite pieces. Polarized light microscopy (PLM) analysis showed that the sample contained 5% chrysotile asbestos. The pieces of transite in the area are deteriorating. Some are crumbling and are covered with powder.

CAPTION: Northeast building, southeast area.
Transite debris.

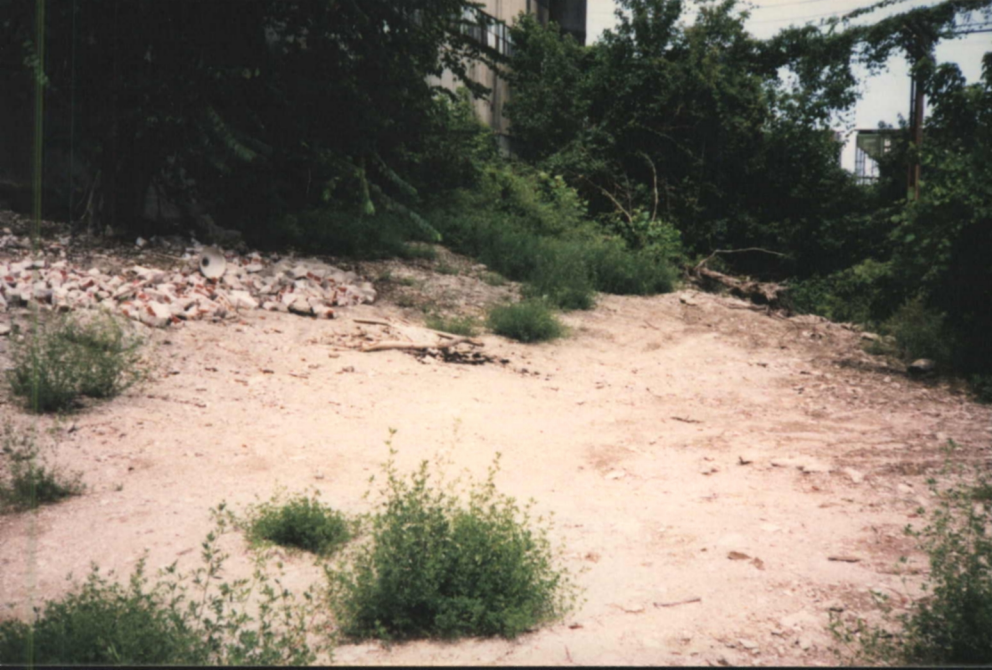
31
Photo #15

CAPTION: Northeast building, southeast area.
Transite debris.

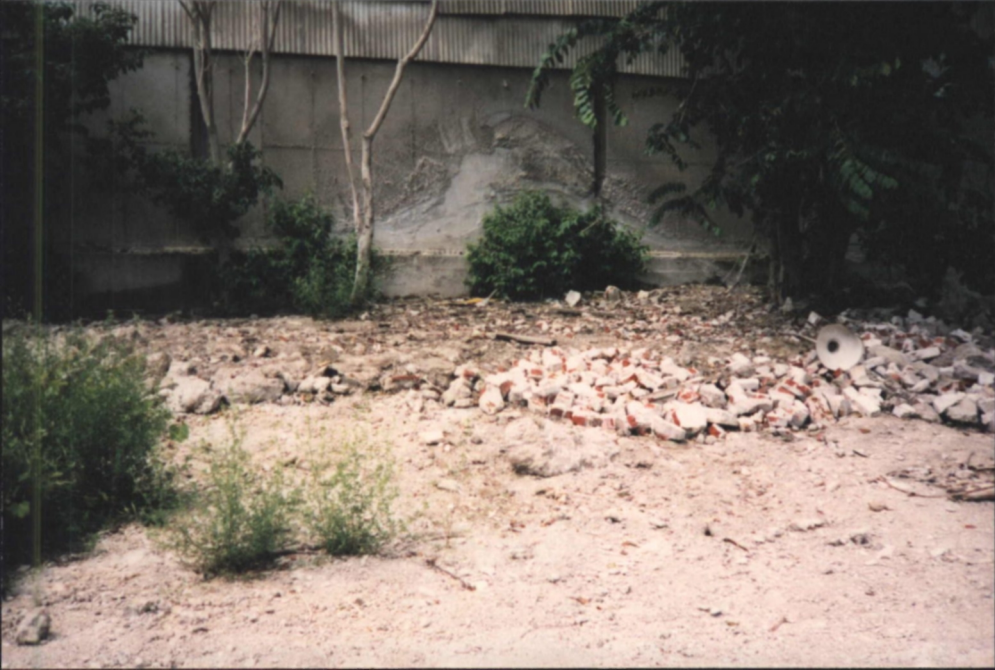
91
Photo #16

CAPTION: Northeast building, southeast area.

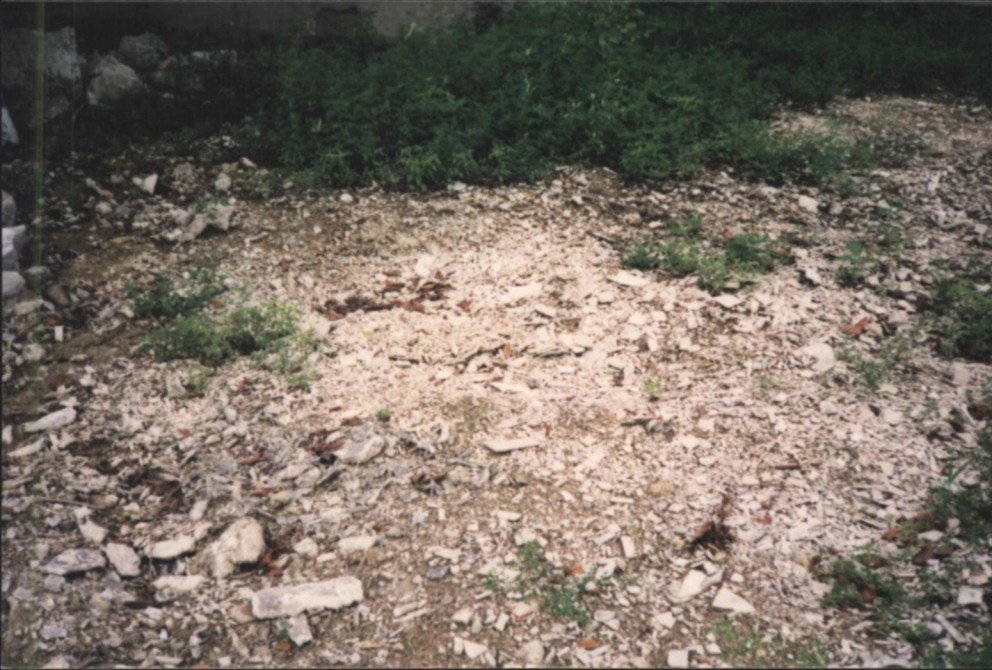
Photo #17

CAPTION: Northeast building, southeast area.
Transite debris.

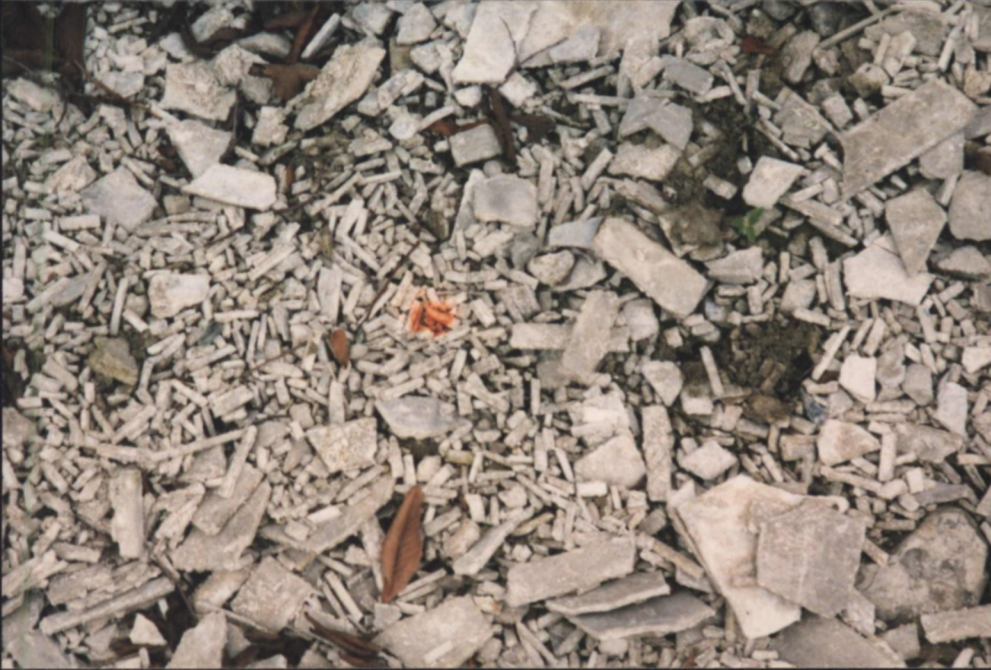
81
Photo #18

| Sample# | Sample Site * (see site map) | Sample Description | Quantity of ACM | Analysis Results | Photo # |
|---|---|---|---|---|---|
| SBR23-001 | SE of NE building. | Transite-deteriorated. Light gray, friable/dusty. | - | Chrysotile, 5% | 17,18 |

CAPTION: Sample site SBR23-001. Northeast building,
southeast area.
Transite debris.

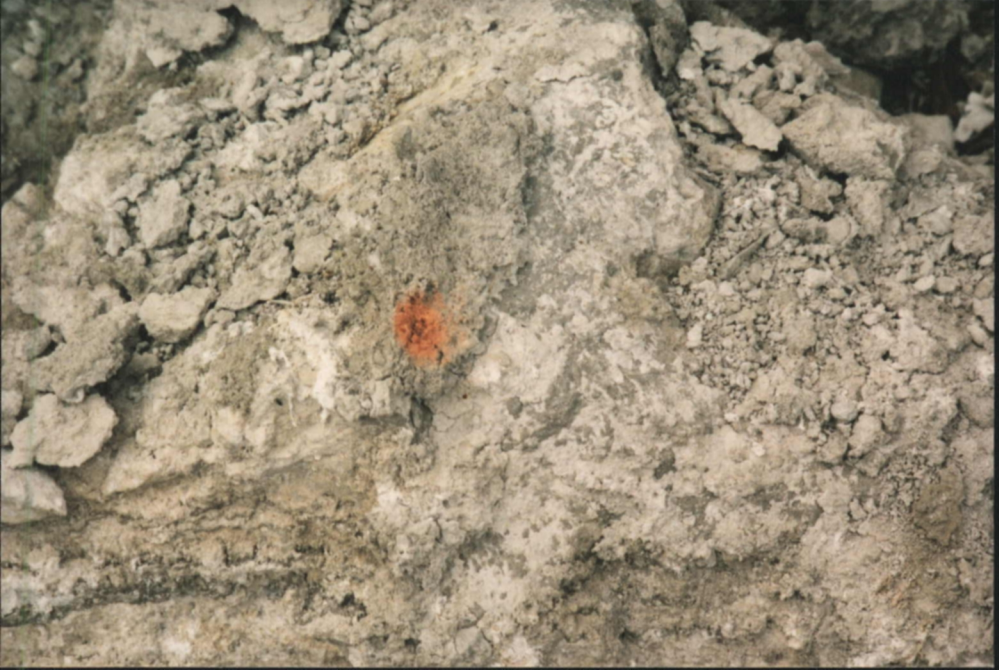
Photo #19

Also located in the southeast area, there appears to be cementitious debris similar to that located by the Maline creek. Sample site SBR23-002 was obtained from this friable material and polarized light microscopy (PLM) analysis showed that the sample contained 30% chrysotile asbestos.

| Sample# | Sample Site * (see site map) | Sample Description | Quantity of ACM | Analysis Results | Photo # |
|---|---|---|---|---|---|
| SBR23-002 | SE of NE building. | Gray, cementious, friable. & White, friable, fibrous. | - | Chrysotile, 30% | 19 |

CAPTION: Sample site SBR23-002. Northeast building,
southeast area.

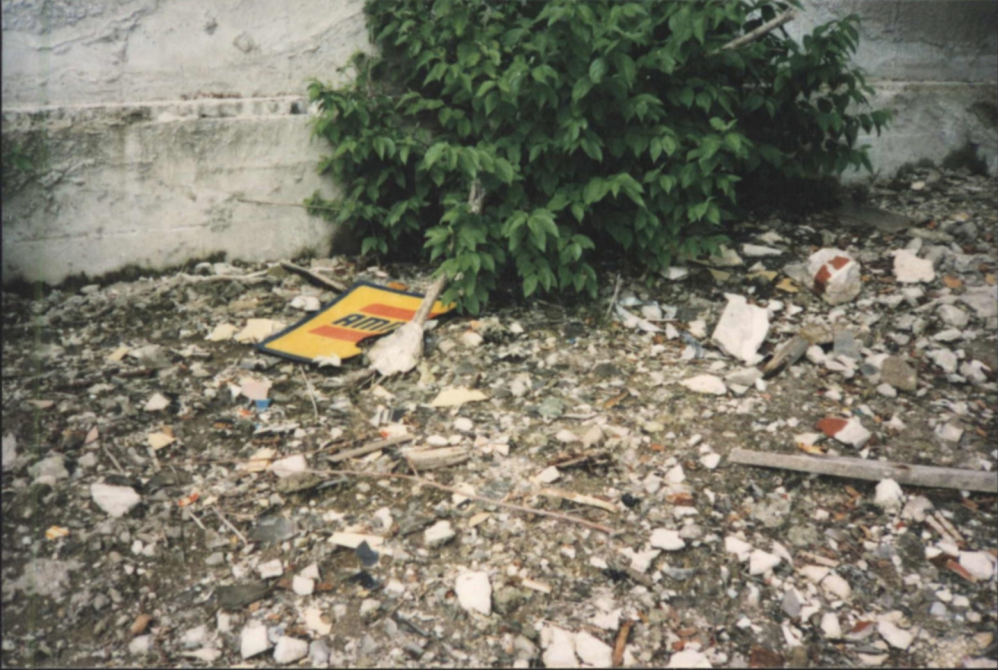
07
Photo #20

Some insulation-type debris was also observed in the southeast area. The material was sampled (Sample site SBR23-003) and polarized light microscopy (PLM) analysis showed that the sample contained 35% chrysotile asbestos.

| Sample# | Sample Site * (see site map) | Sample Description | Quantity of ACM | Analysis Results | Photo # |
|---|---|---|---|---|---|
| SBR23-003 | SE of NE building. | Gray, friable, fibrous. | - | Chrysotile, 35% | 20,21 |

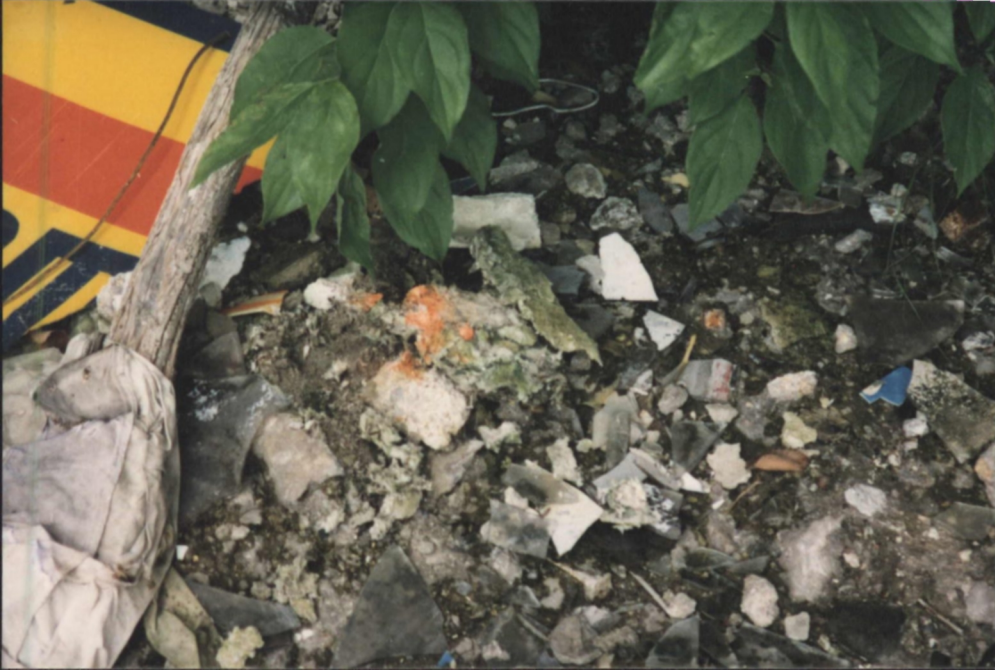
12
Photo #21

CAPTION: Sample site SBR23-003. Northeast building,
southeast area.

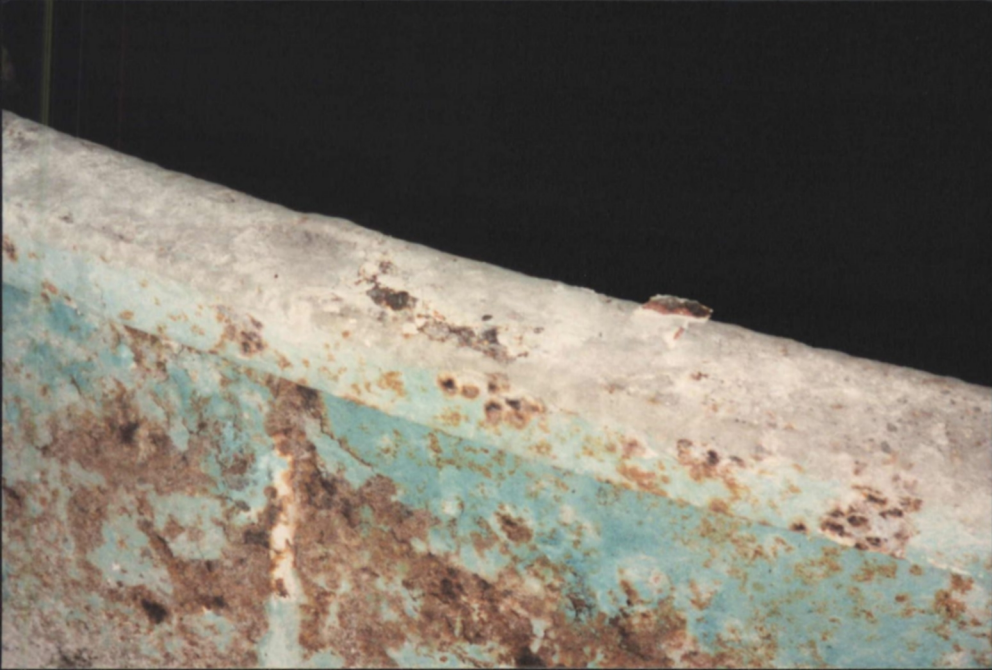
Photo #22

Two conical vessels located on the third level are covered with a gray cementitious material which was sampled (Sample site SBR23-004) (Photos #22, #23 and #24). Polarized light microscopy (PLM) analysis showed that the sample contained no asbestos fibers.

Southwest building, 3rd level.

From top edge of mixing vessel.

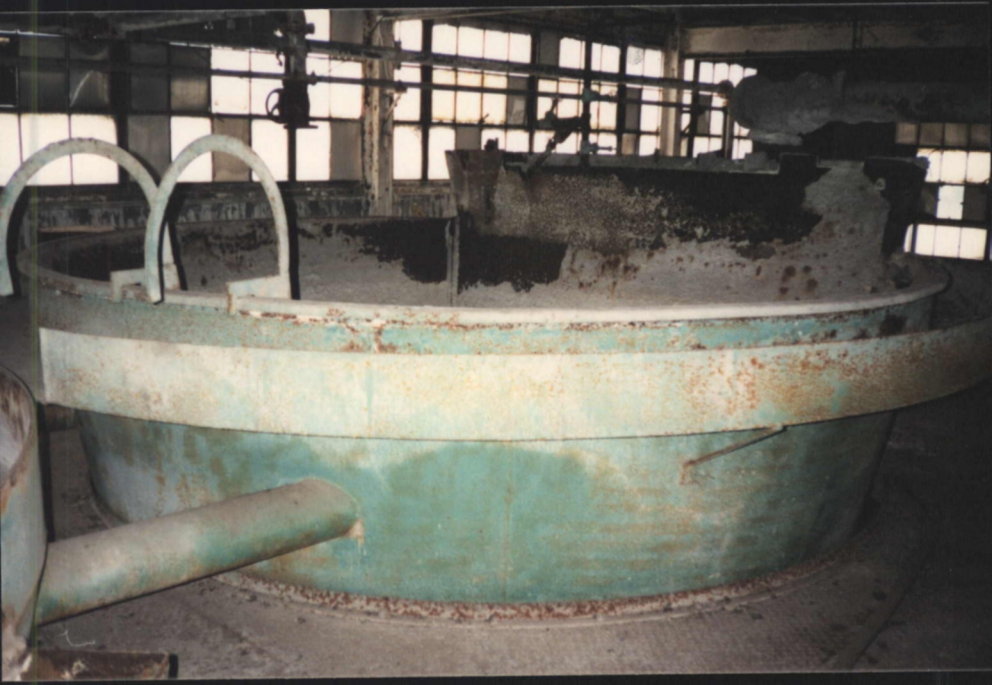
Photo #23

| SBR23-004 | SW building. 3rd floor. SW conical tank. | Gray, slightly friable, granular, cementious. | - | No asbestos detected. | 22,23 |

CAPTION: Sample site SBR23-004.
Southwest building, 3rd level.
Mixing vessel.

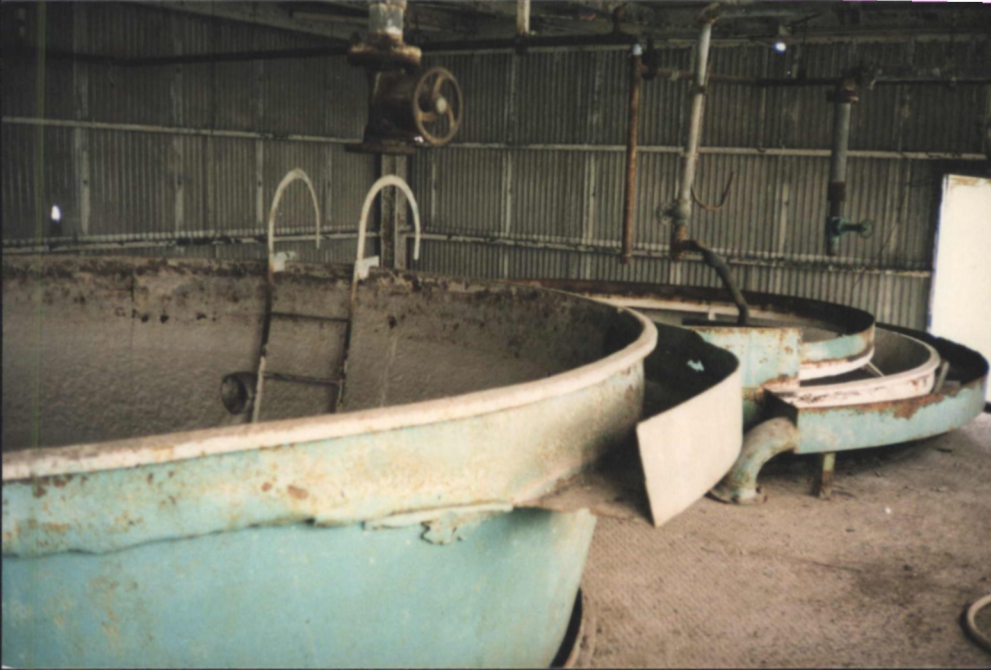
52
Photo #24

CAPTION: Southwest building, 3rd level.

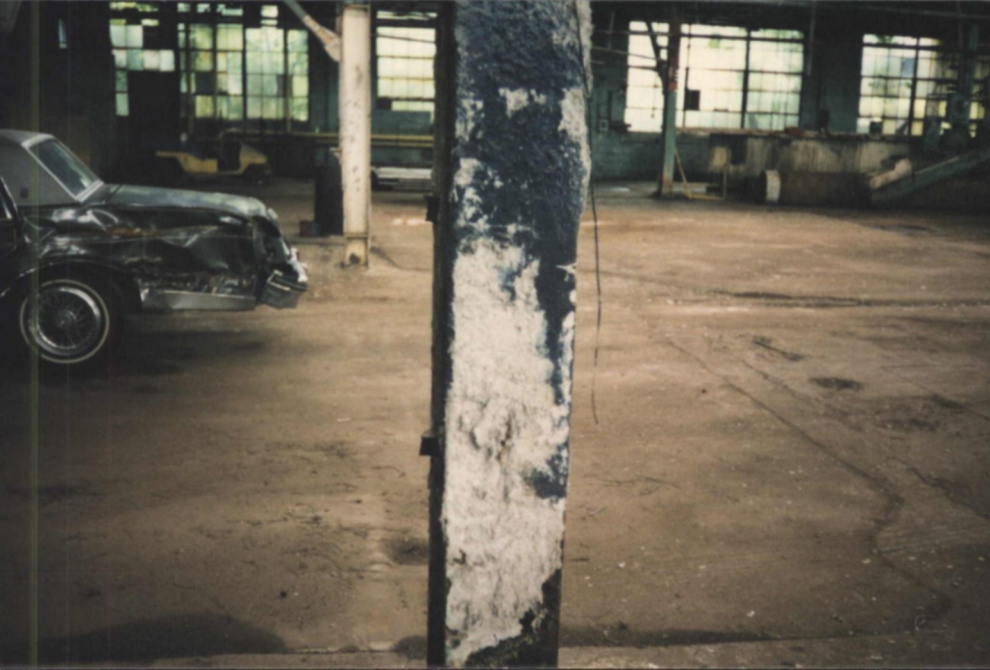
Photo #25

Some possible ACM was also located on a vertical metal support on the ground floor. The material is gray, friable and fibrous (Photo #25).

Friable insulation material on metal post.

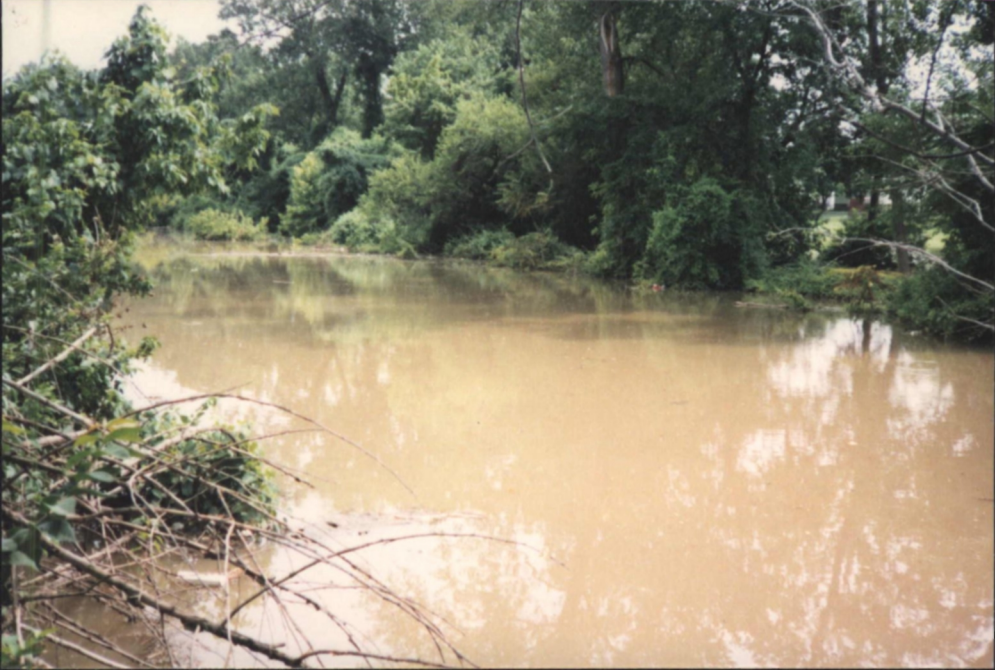
Photo #26

CAPTION: Maline creek from CertainTeed side.
